Performance of Pickering 5-8 FRF Purification Skids

STLE Toronto Section Meeting

October 15, 2024 • Andrew Sit

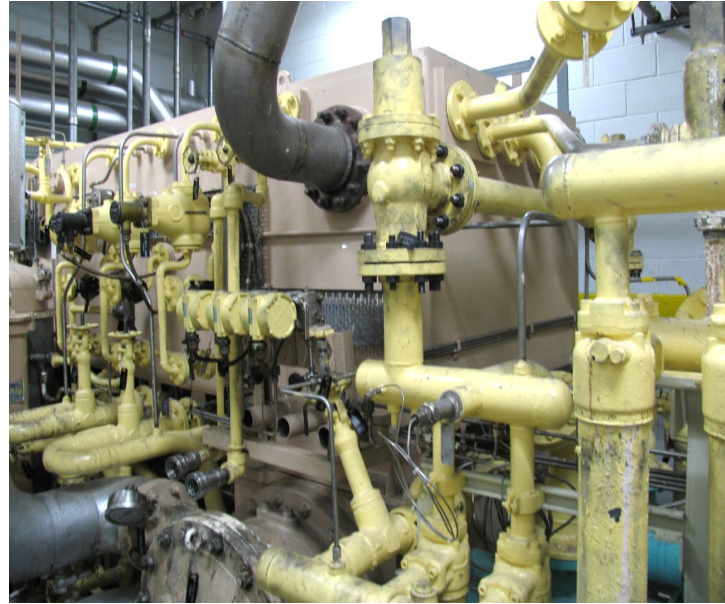
Pickering

OPGN FRF Supply / Power Packages

Consists of:

- Reservoir
- Pumps
- Mechanical and purification filters
- Coolers / heaters
- Vapor extraction fans and/or breathers
- Pressure regulator
- Instrumentation

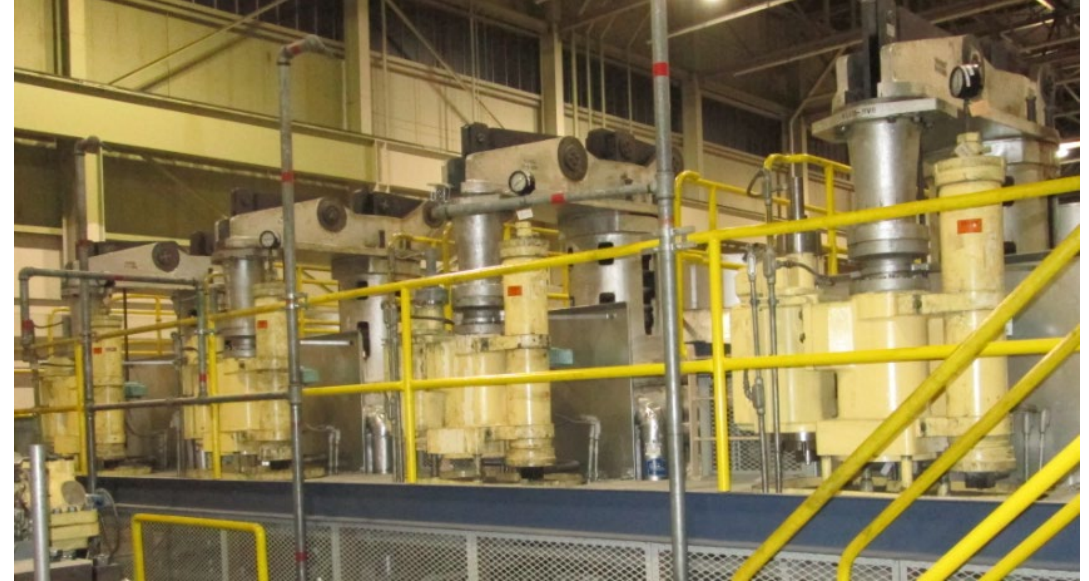
Pickering

Electrohydraulic Control (EHC) Control Valves

EHC control valves include (typically):

- **Governor valves:** controls the steam flow to the HP turbine or reheaters.
- **Over-speed trip valves:** provides protection against turbine over-speed (and potential catastrophic failure) in event of a load rejection or governor failure.
- **Emergency stop valves:** rapidly cuts off main steam supply during turbine trip or shutdown.
- **Intercept valves:** rapidly cuts off steam supply to LP turbines during turbine trip or shutdown.

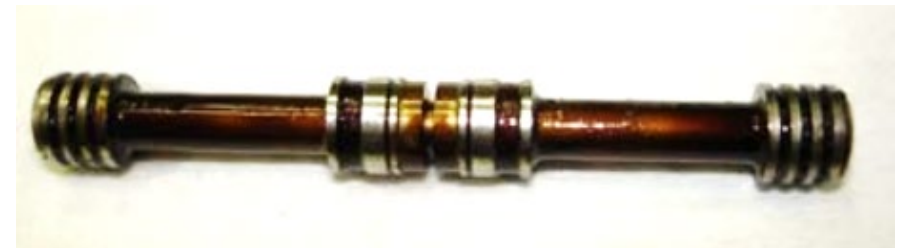
Control Valve Problems

- Stiction and jamming:
 - Electrohydraulic valves, especially servo-valves, are susceptible to stiction and jamming due to fluid contamination by:
 - Varnish deposits
 - Gels from metal salts of phosphate ester decomposition products
 - Ultrafine hard particle $< 5\mu\text{m}$ not removed by system filtration.

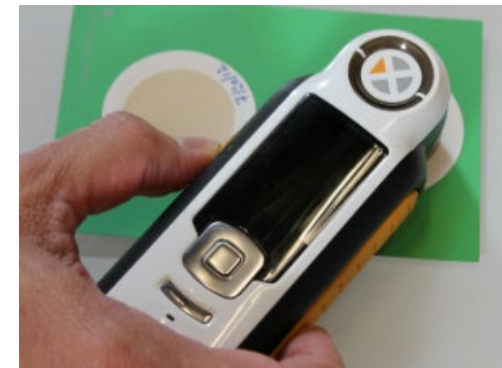
Membrane Patch Colorimetry (MPC)

MPC measures the insoluble colour bodies (soft contaminants) of an oil and is a leading indicator of its varnishing potential.

Original approved as ASTM D7843 in 2013 for in-service turbine oils, the method has been modified for use with EHC phosphate ester FRFs.

The method mixes the fluid with a non-polar solvent and allows time for the soft contaminants to agglomerate before pass the mixture through a 0.45 μm patch.

Colour of the patch is measured by a colorimeter and reported as ΔE value in CIE LAB colour space – this value is also referred to as the MPC value.

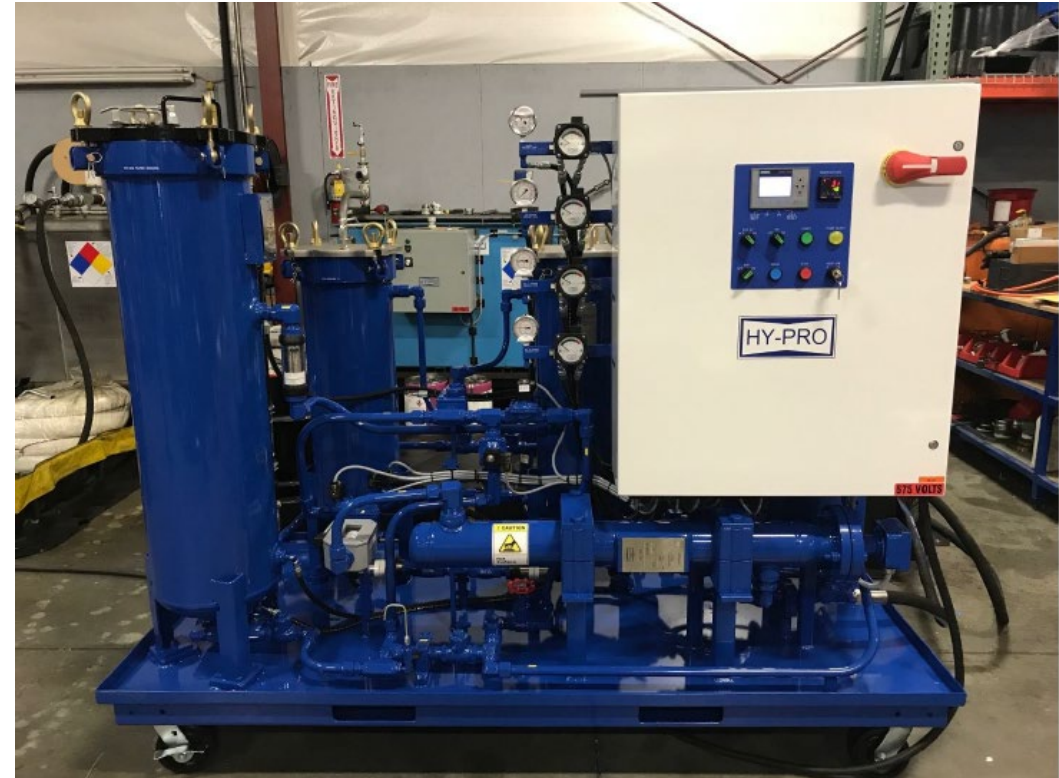
Combination Purification Skid

New skids are commercially available that provide total fluid condition by combining dehydration, electrostatic separation, acid and soluble contaminant removal functions in a single package.

This has been used at Bruce A.

Implemented at Pickering starting Q3 2023.

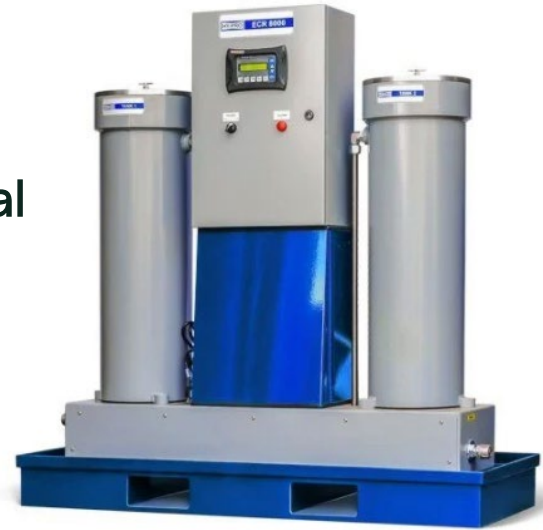
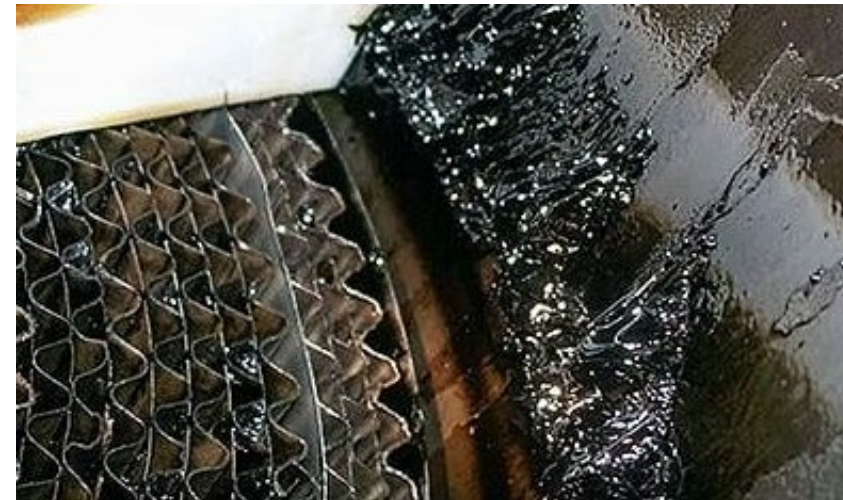
Microfine and Soft Body Particle Removal

Electrostatic separation directs fluid flow between two electrostatically charged plates, and attracting particles to the plates and has shown to be highly effective at removing microfine soft and hard particle, that would not be captured with mechanical filtration.

This method needs high resistivity and low water content so that the electrostatic charge does not dissipate through the fluid.
